HPGe and clover gamma ray detector maintenance

R. K. Gurjar¹, Aman Rohilla², C. K. Gupta², S. Muralithar¹, S. K. Chamoli²
K. Rani¹ and R.P. Singh¹

¹Inter University Accelerator Center, New Delhi- 110067

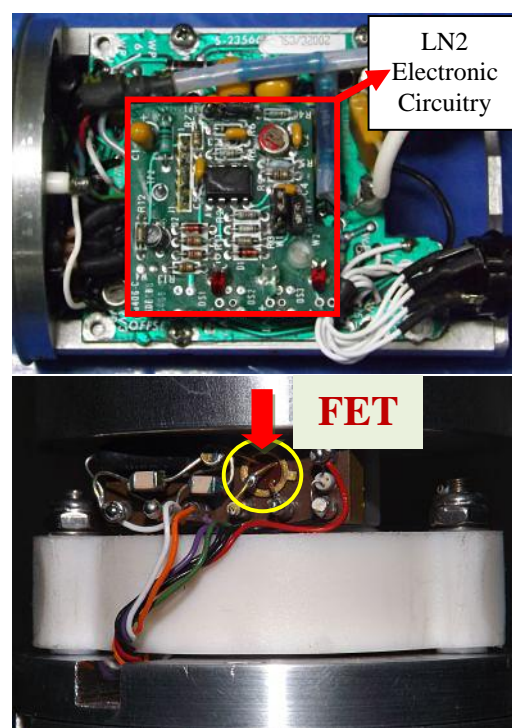
During the servicing of detectors, it was found the some of the detectors were showing high leakage current. The high leakage current is due

to the improper functioning of FET. Due to which the detectors were not taking bias after a certain volt. After a certain volt, the leakage LED was started to glow and the signal was ended. To overcome this problem, first the evacuation and annealing of the detectors were done but it was not successful. Finally, the bad FET was replaced by opening the FET assembly towards the crystal side and replacing it with the new one. This resolves the problem and the detector behavior was normal.

Fig.1. The above figure shows the preamp card and the lower figure shows the inside view with FET assembly
