Scanning for fault detection of the Cathode Pad Chambers of ALICE second muon tracking station using an Amptek Mini X-ray source

W. Shaikh^{1,*}, T. Sinha¹, I. Das¹, and S. Chattopadhyay¹
*High Energy Nuclear and Particle Physics Division,
 Saha Institute of Nuclear Physics, Kolkata - 700064, INDIA*

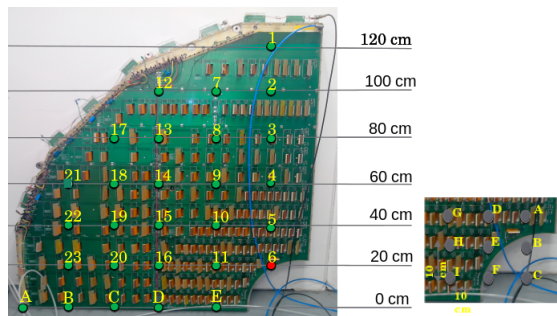
We had tested eight quadrants of tracking station 2 of MS and localised the faulty positions. In Fig. 2 (left), the faulty positions of Chamber 3 Right/Top were marked as red marker by keeping the source at distance 40 cm from the detector. We had found trip at position “6” of the detector.

FIG. 2: X-Ray scan of Chamber 3 Right/Top detector of MS.

in finer steps around the position “6” by keeping the source at distance 10 cm from the surface of detector as shown in Fig. 2 (right). The trips are found at position “E” and “H” of Fig. 2 (right). The faulty positions of all the detectors are reported in following Table-I.

We had scanned eight CPC detectors using the X-ray source to localize the possible faulty regions in this exercise. On the other hand the HV can be raised 1650 V in all these detector if the ionization radiation is absent. This clearly indicates the presence of dielectric materials on the cathode surface which charges up in the presence of the ionization radiation providing a leakage path to the HV on the anode wires. These problems will be addressed in future as a part of High Voltage upgrade work for those detectors.
