Scanning for fault detection of the Cathode Pad Chambers of ALICE second muon tracking station using an Amptek Mini X-ray source

W. Shaikh^{1,*}, T. Sinha¹, I. Das¹, and S. Chattopadhyay¹
*High Energy Nuclear and Particle Physics Division,
 Saha Institute of Nuclear Physics, Kolkata - 700064, INDIA*

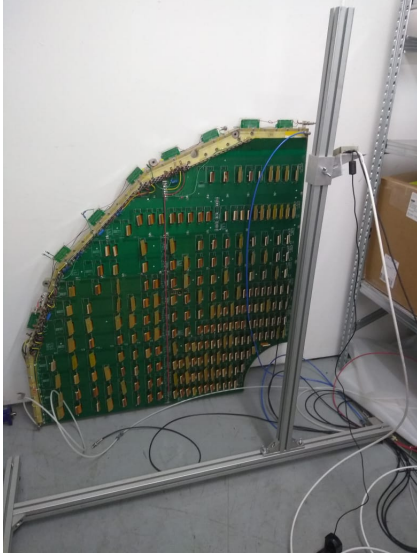
FIG. 1: Systematic arrangements of X-Ray testing.

A dedicated experimental set-up within concrete shielding has been arranged at CERN P2 buffer zone to carry out X-Ray scanning. In Fig. 1, one quadrant of 2nd tracking station together with X-Ray source and the gas distribution rack have been shown.
